1710 ANYWHERE DRIVE, MONTGOMERY, AL 36109

SUBJECT PROPERTY

The following inspection of a property located at 1710 Anywhere Drive, Montgomery, AL 36109, was conducted by Doug Thornton on behalf of All Safe Inspections, LLC, on February 26, 2006 between the hours of 1:00 pm and 3:00 pm for the sole and exclusive use of the client, Mr. John Smith. The inspection of the property was performed under the terms and conditions of an agreement signed by said client at the time of inspection.

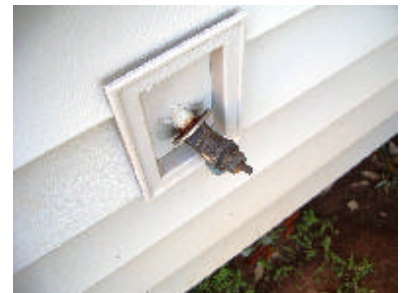
OPERATION: Water pressure satisfactory. Missing/Broken handles.

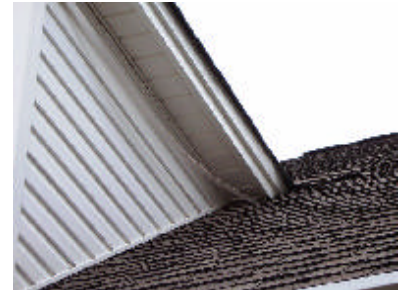
MATERIAL: Vinyl siding, Brick.
CONDITION: Strip of vinyl has fallen off by left attic window. Repair recommended.

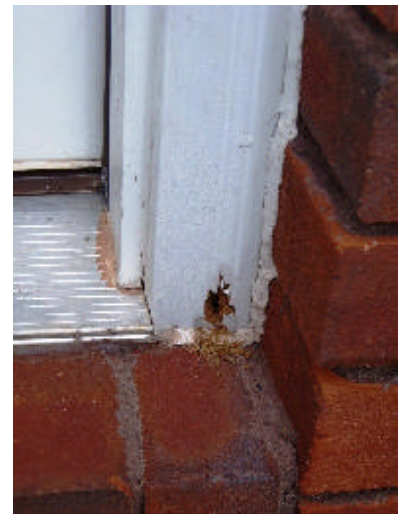
MATERIAL: Wood, Vinyl.
CONDITION: Damage noted, Trim around door to back deck has wood rotting at base on right side. Repair.

- Trim around door to back deck has wood rotting at base on right side. Recommend repair.
- Garage automatic reverse feature is not operational. All overhead doors should have fully operational auto-reverse function to protect small children. This is a simple adjustment.

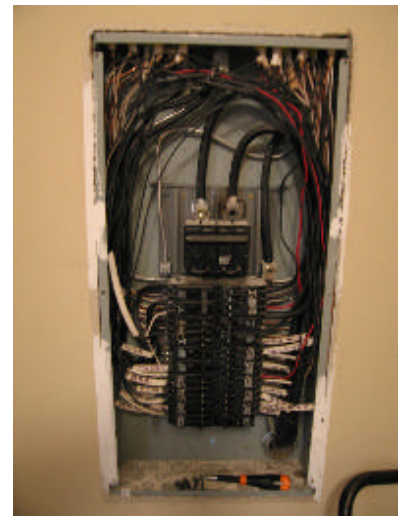
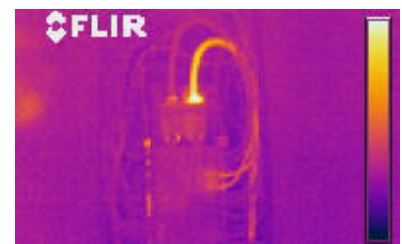
Aluminum. Infrared scan reveals unsafe overheating condition. Have a licensed electrician make further evaluation and corrections as needed.

- Infrared scan reveals unsafe overheating condition in electric service entrance cable. Have a licensed electrician make further evaluation and corrections as needed.

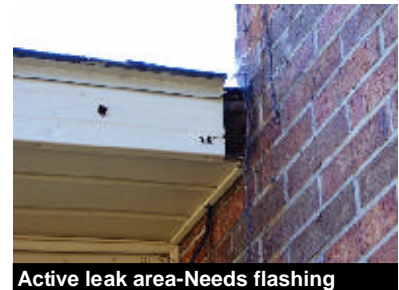
TYPE AND CONDITION: Metal, The potential for water entry is present, Active leakage is noted-rear porch needs proper flashing. Have a licensed roofer repair.

- Infrared scan reveals moisture at porch ceiling area. Moisture meter readings verify an active leak from the exterior flashing. Recommend repair by a licensed roofing contractor.

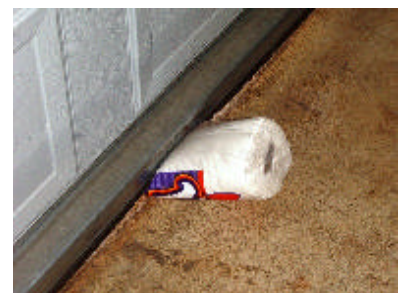
CONDITION: Automatic reverse feature is, not operational.
Note: All overhead doors should have fully operational auto-reverse function.

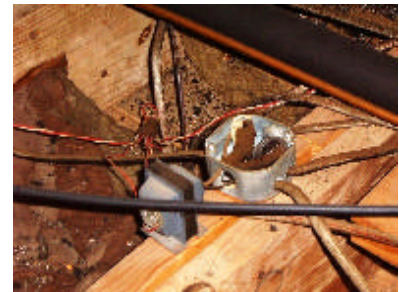
Open junction boxes need covers.

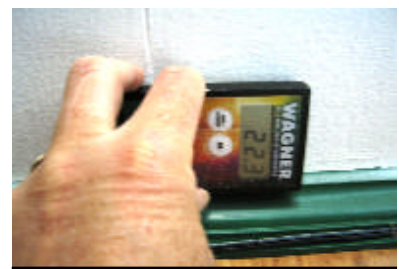
Dry section of ceiling

Staining is noted at the ceiling or upper wall area. Moisture meter readings indicate stains are wet. It appears active leakage is occurring. The source of water leakage (lack of roof flashing) should be corrected before any cosmetic repairs take place.

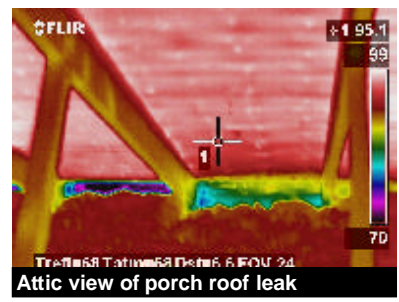
Moist area of ceiling

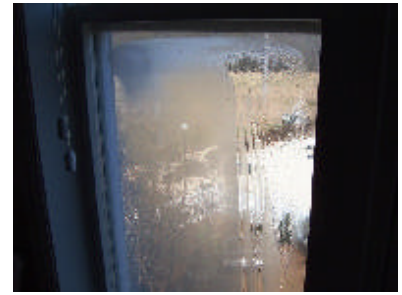
Windows: Cracked (no vapor seal) center window.

- Broken window panes noted in family room and master bedroom. Replacement recommended.
- Dishwasher leaked during testing. Recommend repair by a licensed technician.

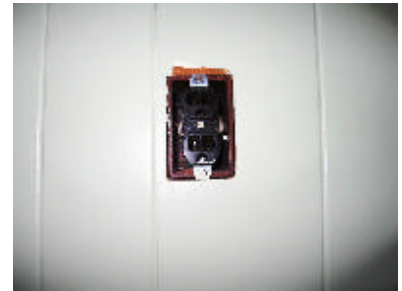
Trim: Good overall condition.
Electrical: OUTLETS-Good overall condition. Loose, cracked or missing outlet covers are noted.

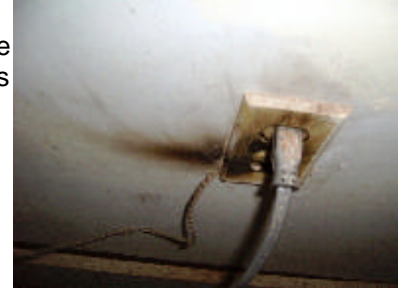
OUTLETS- Sign of electrical arcing on outlet behind washer. A licensed electrician should be called to make further evaluation and repairs as needed.

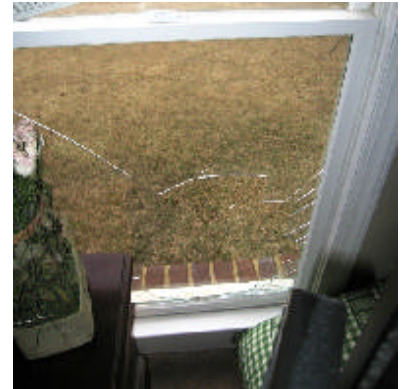
Cracked or broken window pane noted-right side of bed.

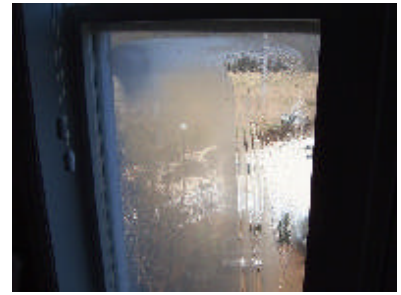
Windows: Cracked (no vapor seal) center window.

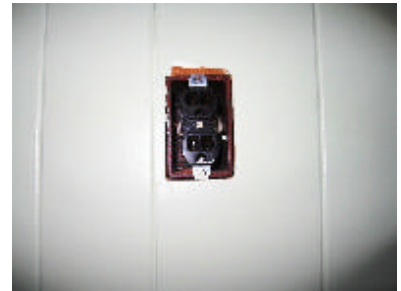
Trim: Good overall condition.
Electrical: OUTLETS- Good overall condition. Loose, cracked or missing outlet covers are noted.

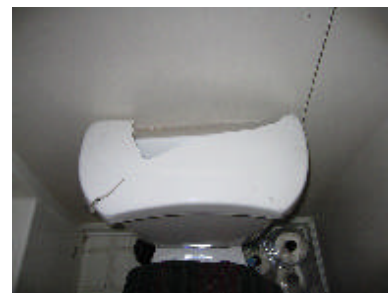
Toilet has sustained damage to lid.
Recommend replacement.
