1710 ANYWHERE DRIVE, MONTGOMERY, AL 36109

SUBJECT PROPERTY

The following inspection of a property located at 1710 Anywhere Drive, Montgomery, AL 36109, was conducted by Doug Thornton on behalf of All Safe Inspections, LLC, on February 26, 2006 between the hours of 1:00 pm and 3:00 pm for the sole and exclusive use of the client, Mr. John Smith. The inspection of the property was performed under the terms and conditions of an agreement signed by said client at the time of inspection.

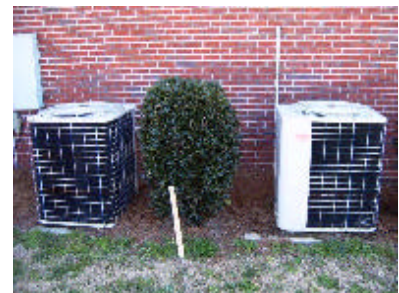
MODEL: 663cj048-c.
SERIAL #: 0901e02783 and 0901e05634.
POWER SOURCE: 220 Volt, Electrical disconnect present.

ESTIMATED AGE: 4 years.
CAPACITY OF UNIT: 4 ton.
TYPE: Electric. Central.
RETURN AIR TEMPERATURE: 52 F.
SUPPLY AIR TEMPERATURE: 70 F.
AIR TEMPERATURE DROP: 18 F-Good cooling. (15-20 F temperature drop is desired)
SYSTEM CONDITION: Satisfactory. Annual servicing is recommended for efficient performance.
CONDENSATE LINE: Condensate line installed.
NORMAL CONTROLS: Satisfactory.

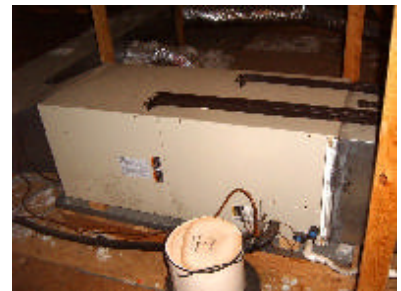
SYSTEM TYPE: Forced Air.
FUEL TYPE AND NOTES: Electric Heat Pump-Same system components for Heating and Cooling.
CAPACITY OF UNIT: 4 ton.
APPROXIMATE AGE IN YEARS: 4 years.

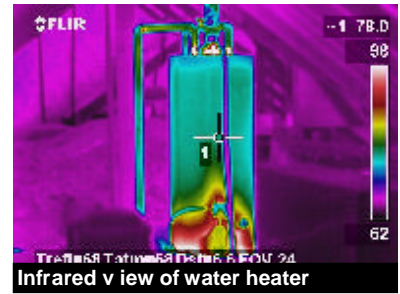
TYPE: Gas-Rheem Model: rh40dv Serial: 0402g4539

CONDITION: Satisfactory. Pressure relief valve noted. Drain pan present. Flue intact.

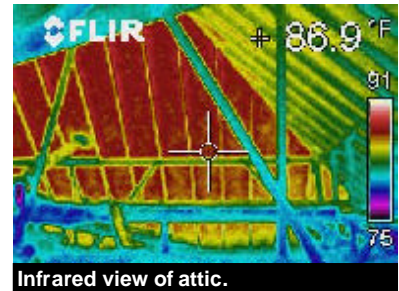
INSULATION TYPE AND CONDITION: Blown Fiberglass-Satisfactory.

DEPTH AND R-FACTOR: 13 inches, R-30.

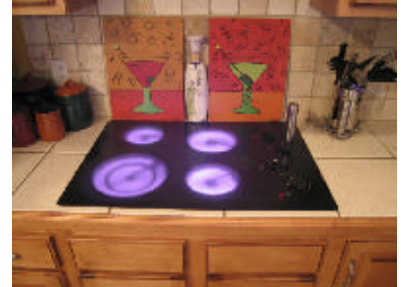
**TYPE/
CONDITION:** Electric. Satisfactory.
